Application Fact Sheet - Screw Conveyor Cost Savings

Animal Feed Screw Conveyor

Screw Conveyor Shaft Wear Solution

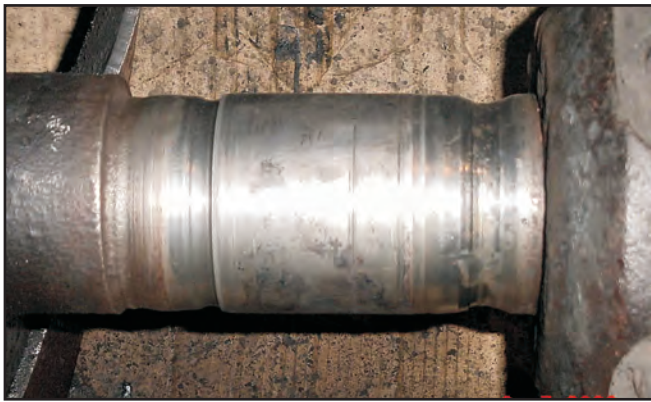
A customer was having problems with rubbing seals which were creating excessive wear and damage to screw conveyor shafts on an animal feed conveyor. This created high maintenance costs and limited operational use of the conveyor.

To cope with these problems, the customer had a regular bearing change-out and shaft rebuild during the annual maintenance period which incurred regular shaft rebuild costs in the region of £350. An additional bearing changeout was also required during production every year.

Above: Typical annual shaft damage prior to conversion.

To rectify the problem, Cooper recommended shaft wear collars to be fitted to either side of the 01E 90mm EX (Expansion) bearing installed in a special strap hanger application on the shaft of the screw conveyor.

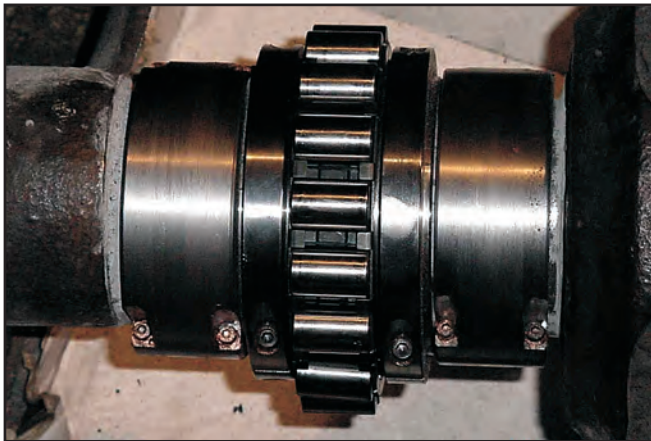
Below: Wear collars shown in position before fitting of housing.

The application required special modification to the cartridge and enabled the screw conveyor to operate continuously throughout the processing period without the need for any bearing or seal related stoppage. This has resulted in significant cost savings for the customer.

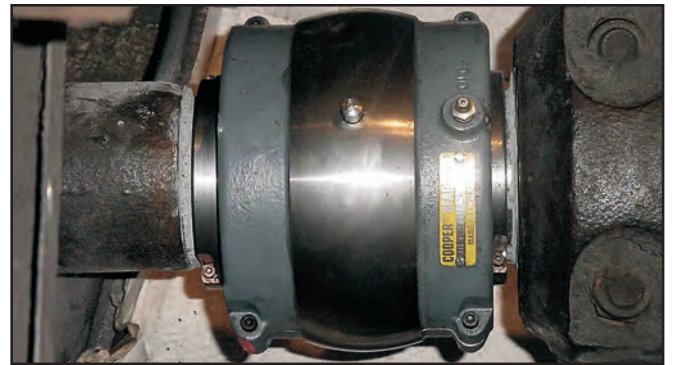
Below: Installation of cartridge in screw conveyor.
